An analysis of possible microbiologically
influenced crevice corrosion of 316 stainless
steel in a seawater environment

An Analysis of Possible Microbiologically Influenced Crevice Corrosion of 316 Stainless Steel in a Seawater Environment

Submitted to the Department of Ocean Engineering
on August 9, 1996 in Partial Fulfillment of the
Requirements for the Degree of Master of Science in
Oceanographic Engineering

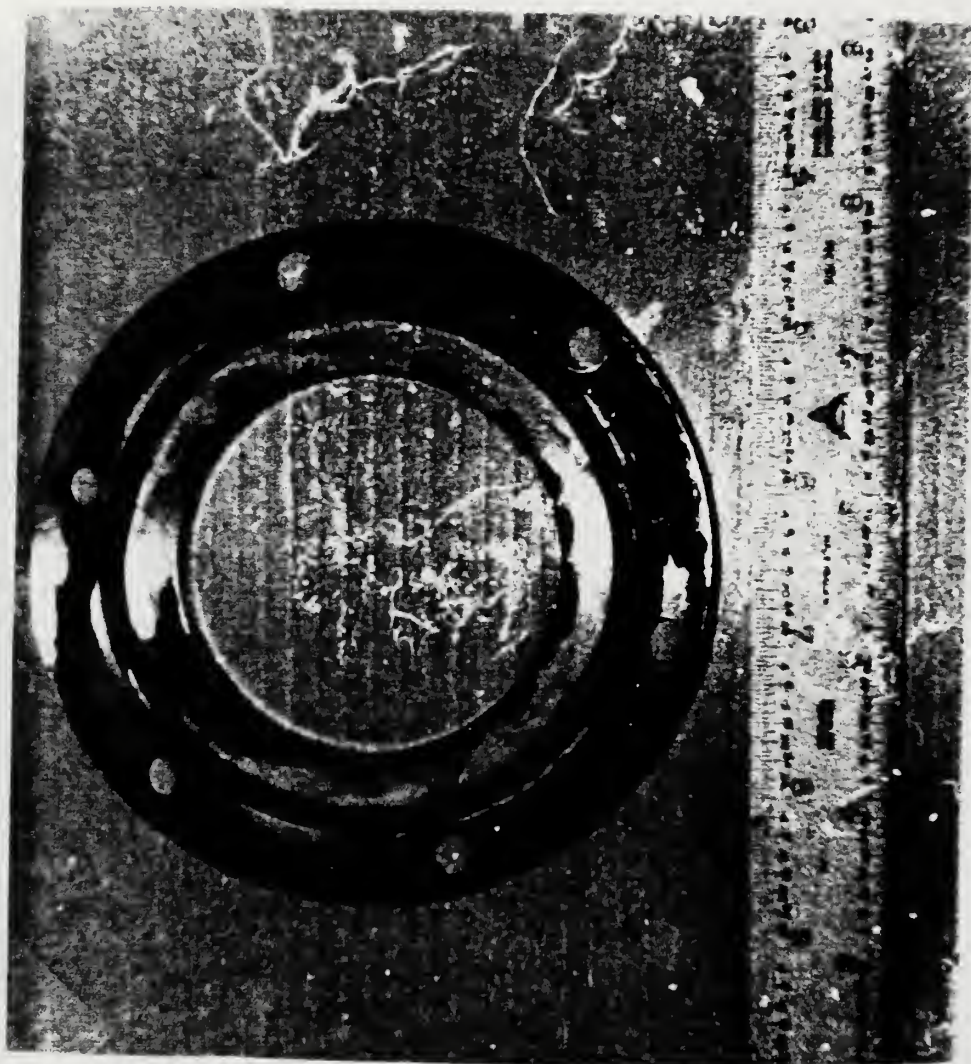
Figure 1-1: Corrosion-Damaged Specimen #1 (O-ring grooved side)

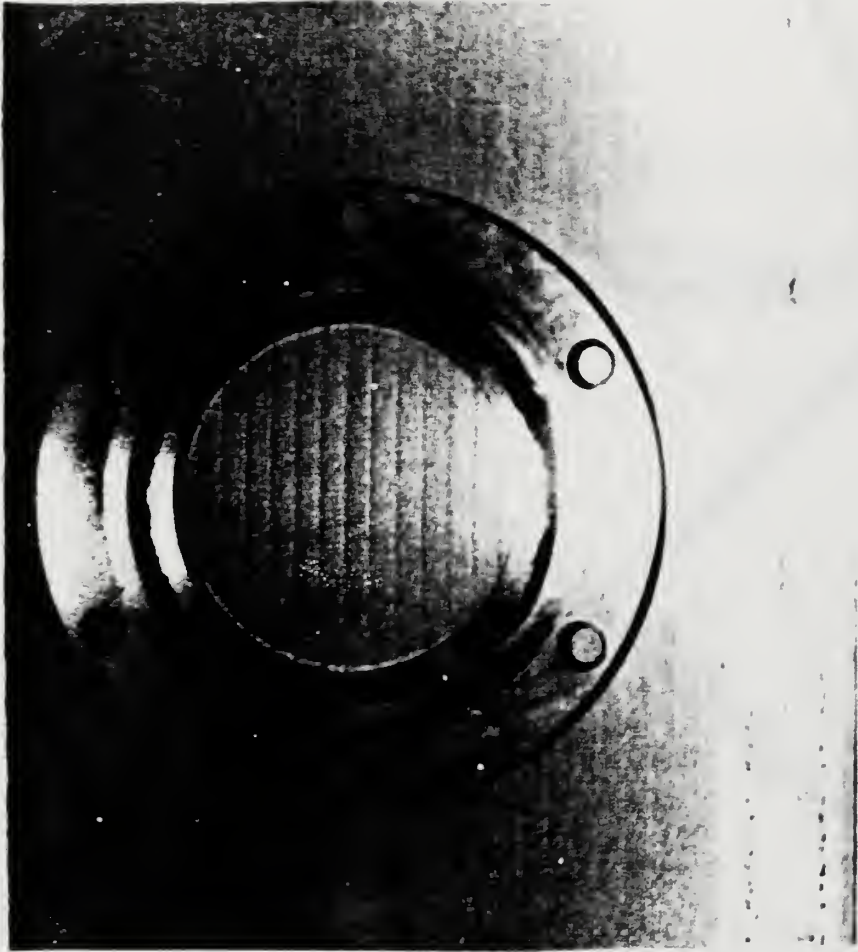
Figure 1-2: Corrosion-Damaged Specimen #1 (reverse side)

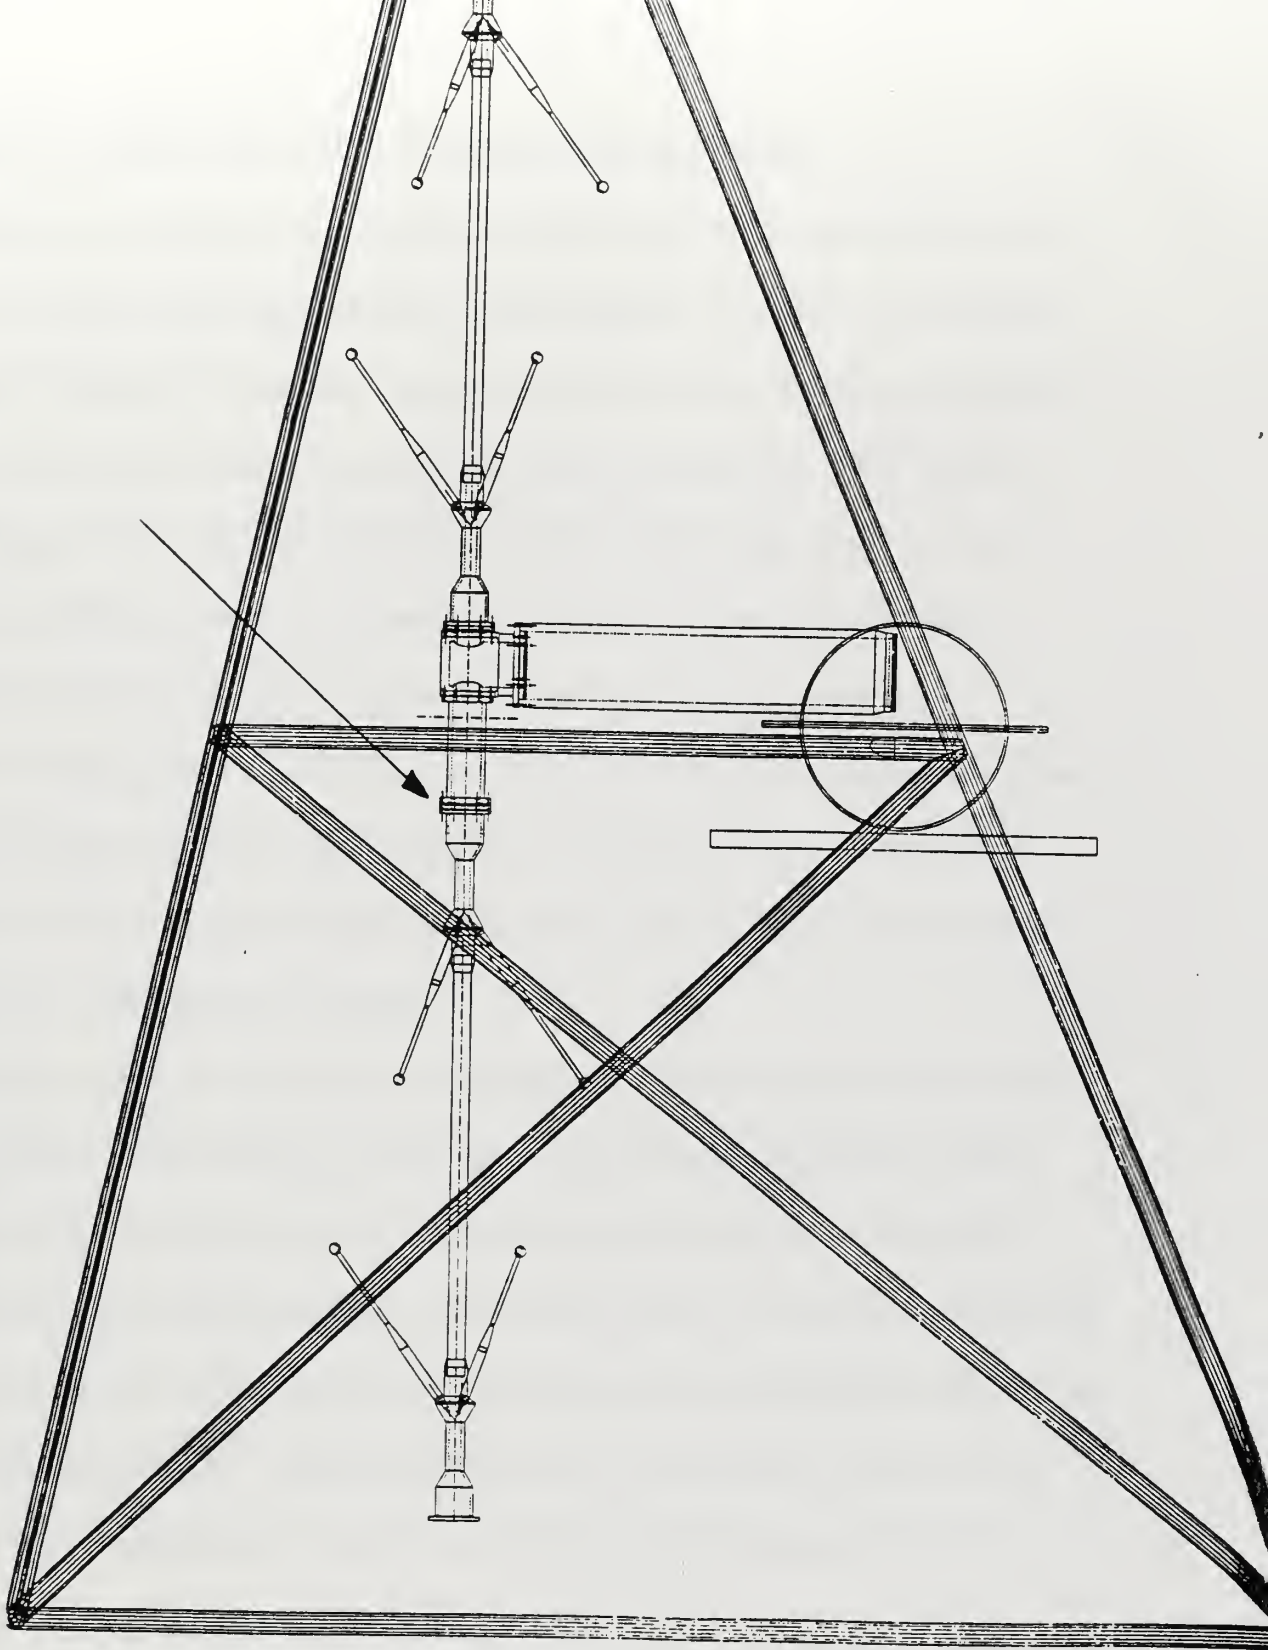
experiment which exhibited this rapid and severe crevice corrosion. These components were 316 Stainless Steel space rings which were used to join two pressure housings on a large fixed instrument. The components were produced on an end-mill in the machine shop at the Woods Hole Oceanographic Institution and given a smooth surface finish. Each has six holes through which fasteners passed and an O-ring groove milled into one side. Outer diameter is 4.5 inches, inner diameter is 3.5 inches, and thickness is 3/8 inches. Figures 1-1 and 1-2 are photographs of one of these corrosion-damaged components, while figure 1-3 is a line drawing of the vorticity instrument suspended within its tripodal frame for deployment on the sea bottom. The location of the two rings in the pressure housing is indicated by the arrow. The rings were separated from the rest of the instrument by spacers composed of Delren plastic.

Figure 1-3: Line Drawing of Vorticity Instrument within Support Pyramid

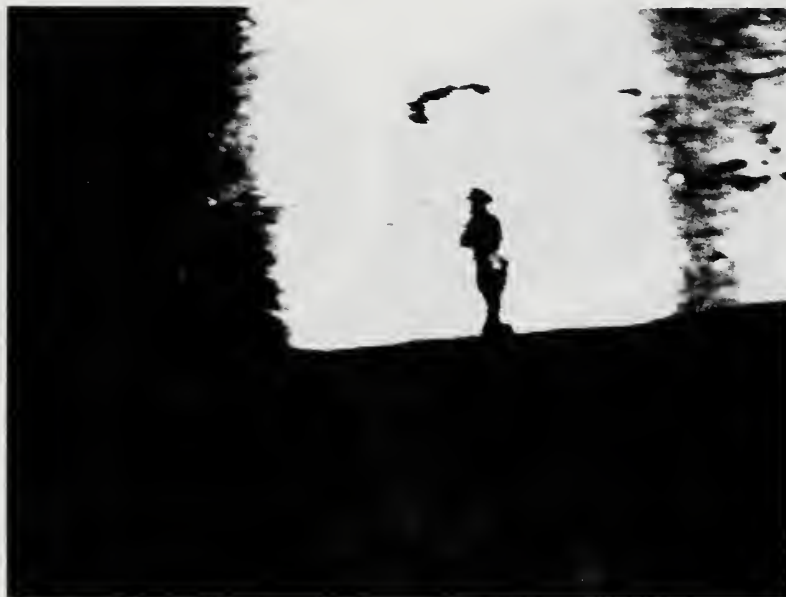
Figure 4-2. Specimen #1 Edge View of Deep Pit (20X magnification)

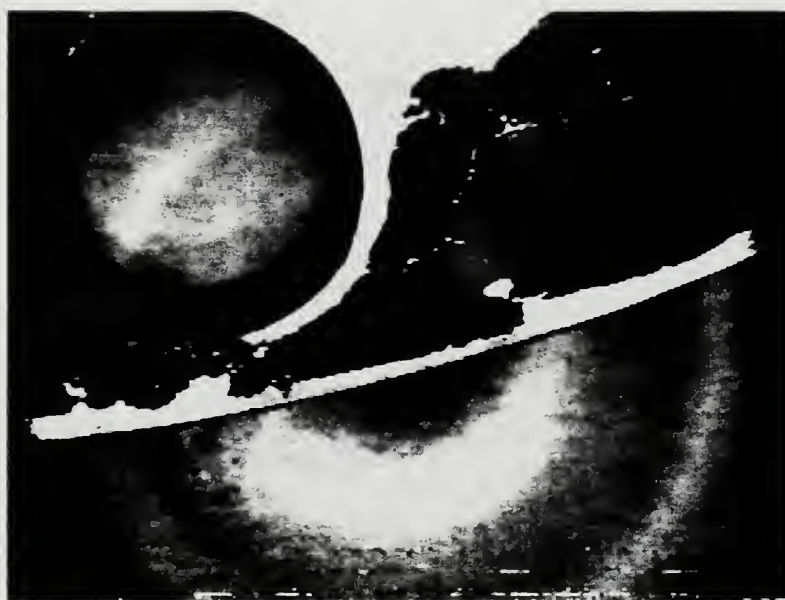
Figure 4-4 Specimen #2 Hemispherical Pits (20X magnification)

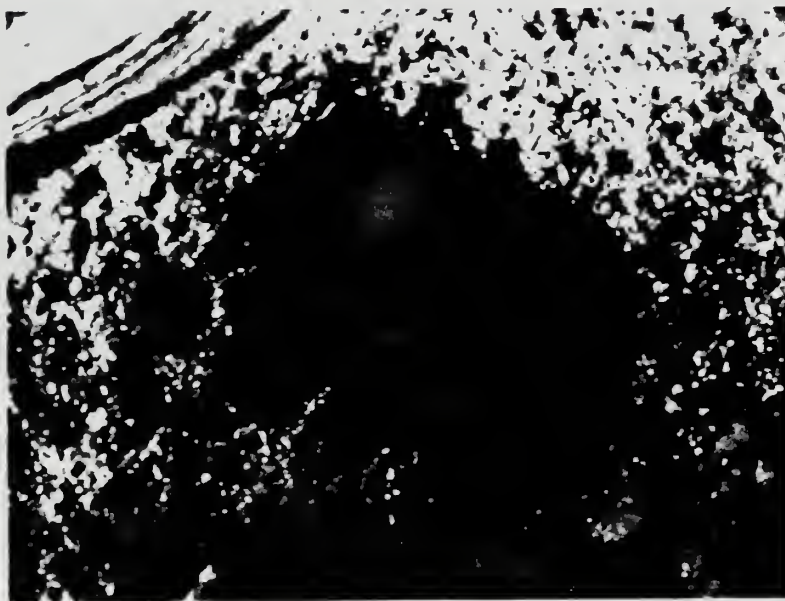
Figure 4-6 Specimen #1 Cavernous Pit (100X magnification)

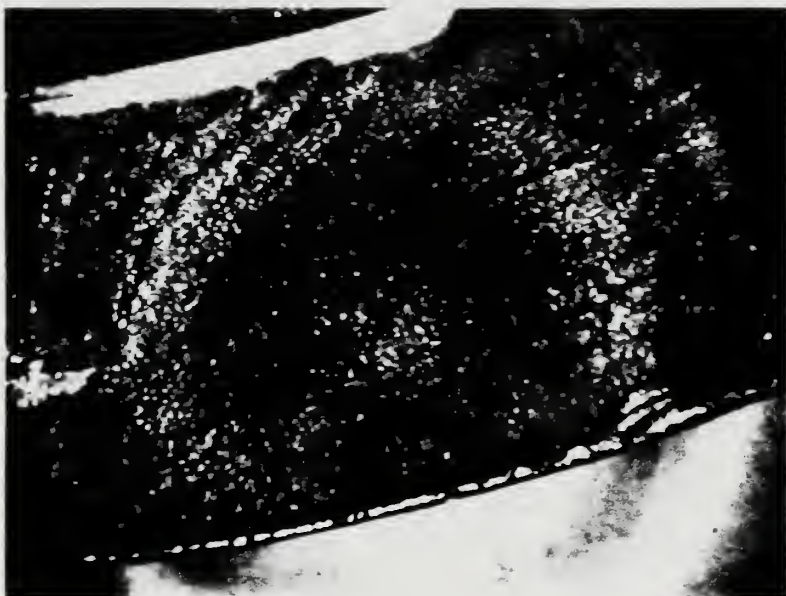
Figure 4-10. Specimen #2 Hemispherical Pits (20X magnification)

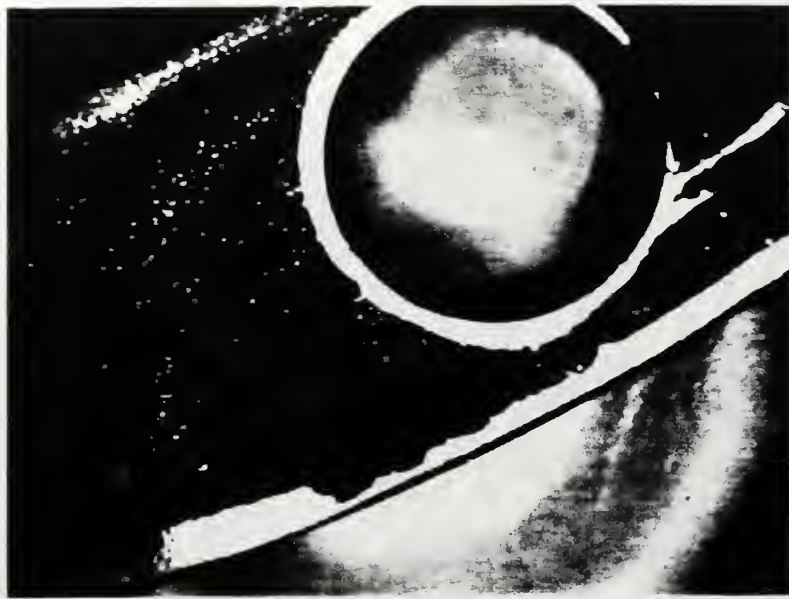
Figure 4-11: Specimen #2 Hemispherical Pits (20X magnification)

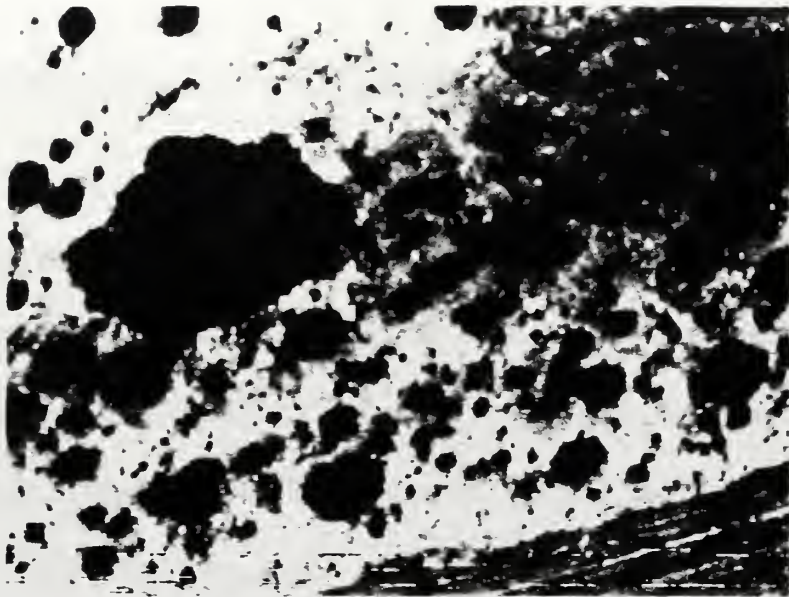
Figure 4-13: Specimen #2 Deep Pits (100X magnification)

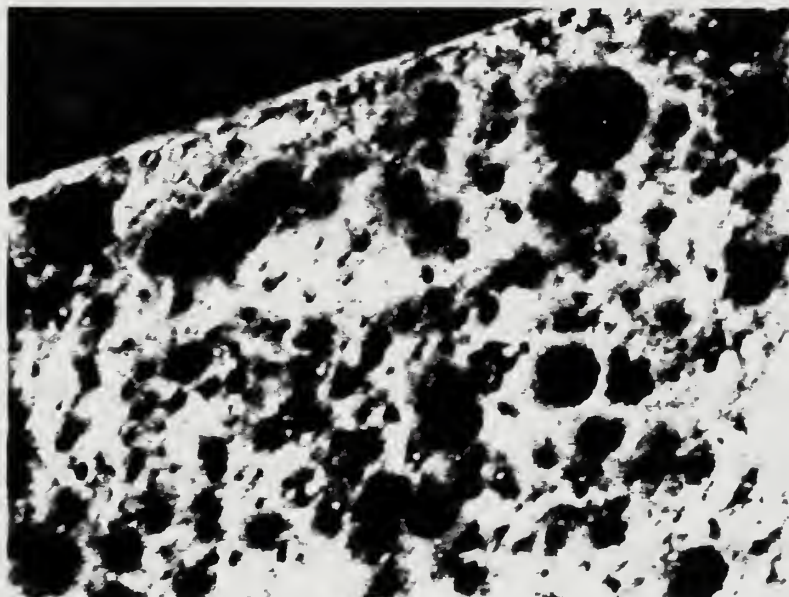
Figure 4-14 Specimen #2 Deep Pits (100X magnification)

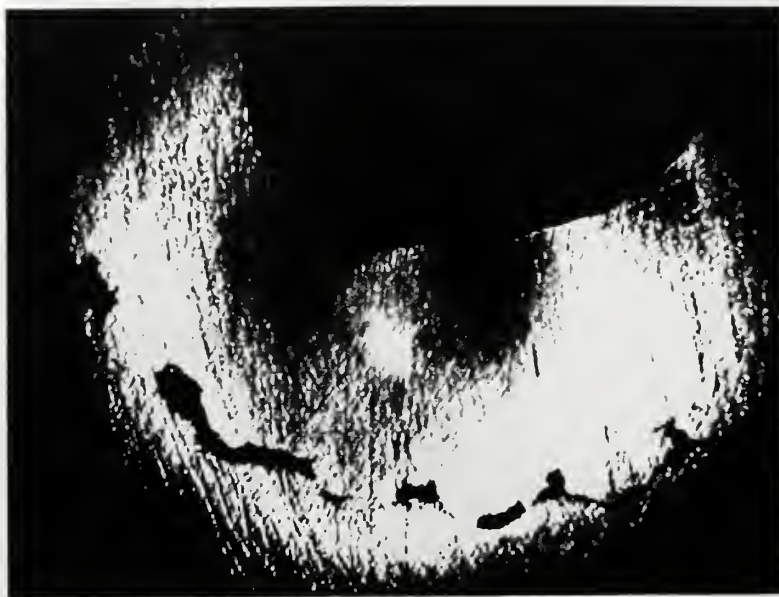
Figure 5-1: Sterile Seawater Specimen (20X magnification)

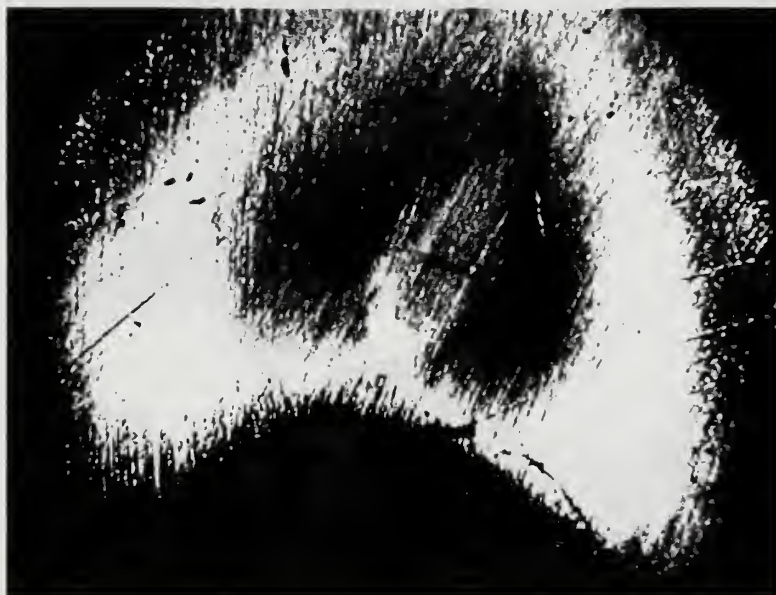
Figure 5-2: Sterile Seawater Specimen (20X magnification)

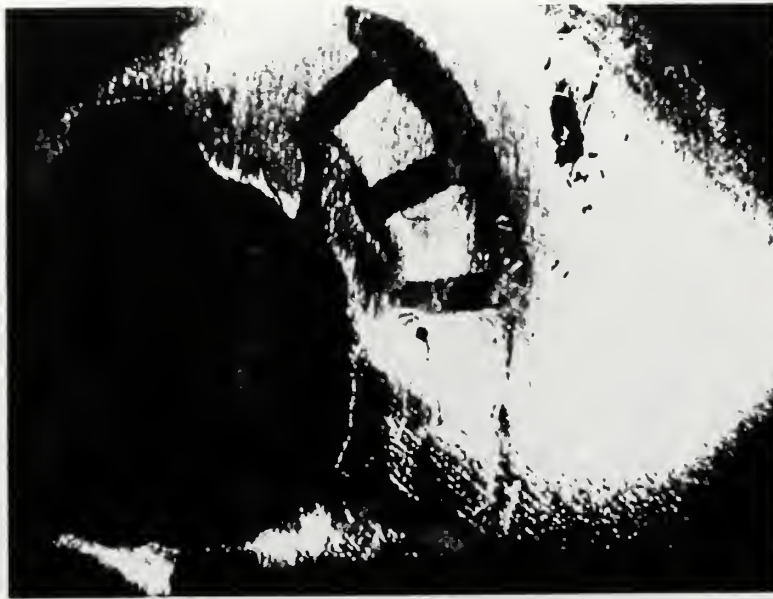
Figure 5-3: Active Seawater Specimen (20X magnification)

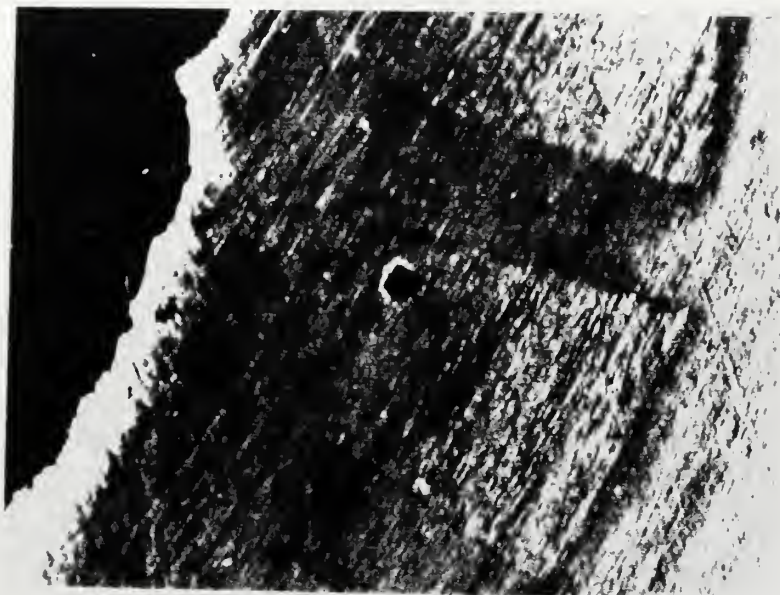
Figure 5-7: Active Seawater Pit (60X magnification)

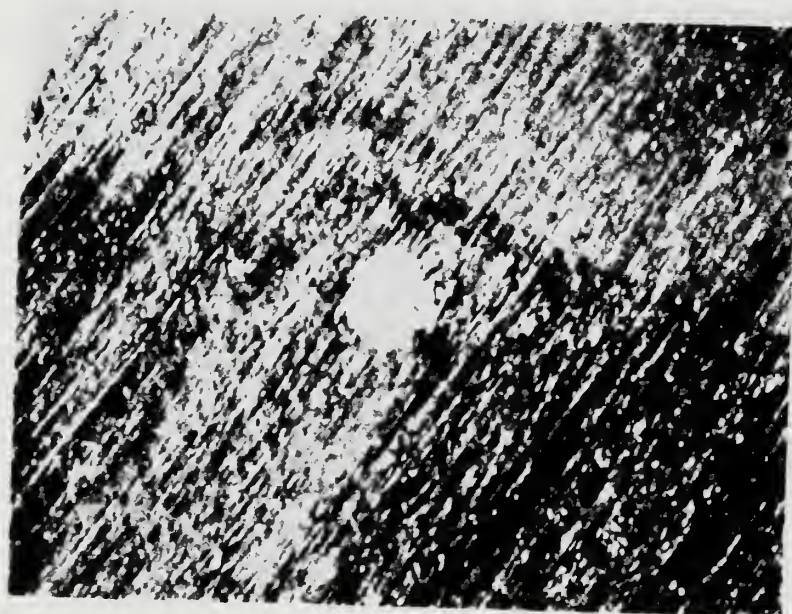
Figure 5-8: Active Seawater Pit (100X magnification)

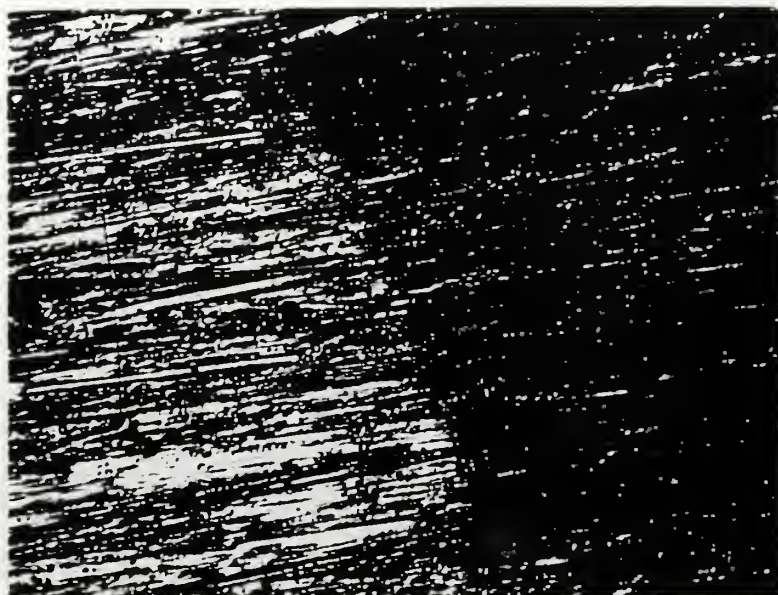
Figure 5-9: Active Seawater Specimen (600X laserscope magnification)

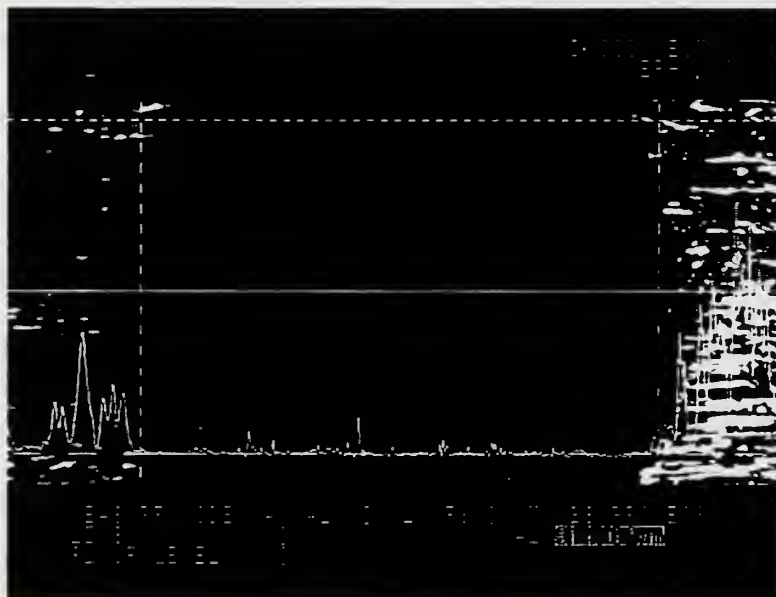
Figure 5-12: Active Seawater Pit (600X laserscope width/depth measurement)
